Move Out

Move-Out Conditions

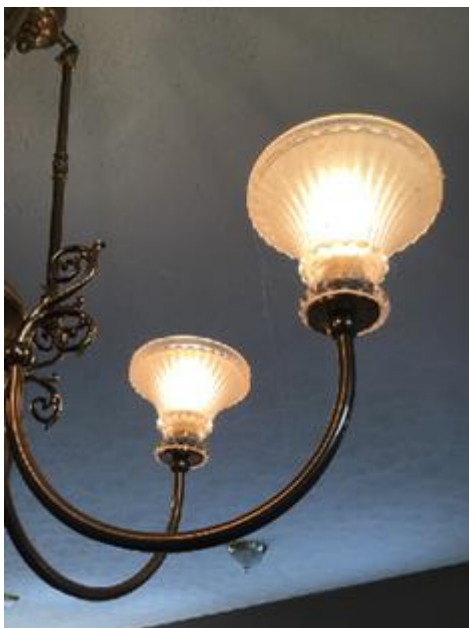
Entry	CONDITION	ACTION	COMMENTS
Baseboard	- S - -	None	
Ceiling	- S - -	None	
Door/Knob/Lock	- S - -	None	
Flooring	- S - -	None	
Light Fixture/Fan	- - ! -	Cleaning Required	Needs cleaned, cobwebs
Security/Screen Door	- S ! -	Maintenance Required	Missing handle
Switch/Outlet	- - ! -	Maintenance Required	Missing screws
Walls	- S - -	None	Some marks on wall

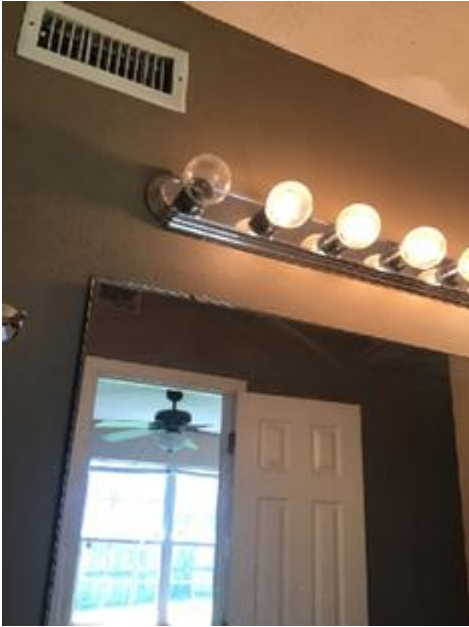
Bathroom: Master bathroom	CONDITION	ACTION	COMMENTS
Baseboard	- S - -	None	
Cabinet/Counter/Shelving	- S - -	None	
Ceiling	- S - -	None	
Door/Knob/Lock	- S - -	None	
Exhaust Fan	- S - -	None	
Flooring	- S - -	None	
Light Fixture	- - ! -	Maintenance Required	Missing light bulb=\$5
Medicine Cabinet/Mirror	- - ! -	Cleaning Required	
Plumbing/Drain	- - ! -	Maintenance Required	Hot water trickles out of shower and sinks
Shower Door/Rail/Curtain	- S - -	None	
Sink/Faucet	- S - -	None	
Switch/Outlet	- S ! -	Maintenance Required	Outlet was painted on, needs replaced
Toilet	- S - -	None	
Toilet Paper Holder	- S - -	None	
Towel Rack	- S - -	None	
Tub/Shower	- S - -	None	
Walls	- - ! -	Painting Required	Needs paint

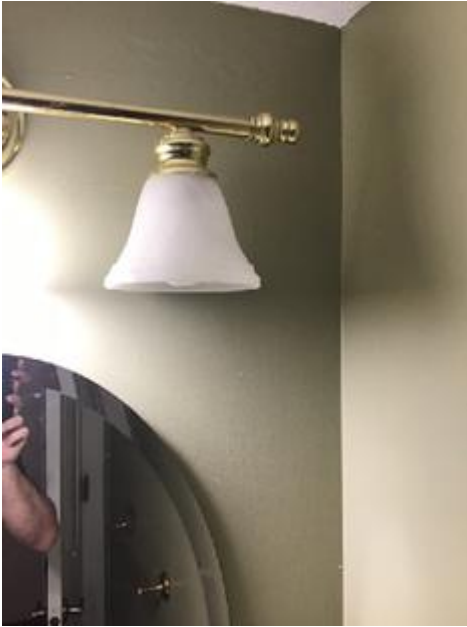
Bathroom 2	CONDITION	ACTION	COMMENTS
Baseboard	- S - -	None	
Cabinet/Counter/Shelving	- S - -	None	
Ceiling	- S - -	None	
Door/Knob/Lock	- S - -	None	
Exhaust Fan	- S - -	None	
Flooring	- - ! -	Maintenance Required	
Light Fixture	- S - -	None	Replaced light bulb-\$5
Medicine Cabinet/Mirror	- S - -	None	
Plumbing/Drain	- - ! -	Maintenance Required	Hot water trickles out of sink and shower
Shower Door/Rail/Curtain	- S - -	None	
Sink/Faucet	- S - -	None	
Switch/Outlet	- S - -	None	
Toilet	- S - -	None	
Toilet Paper Holder	- S - -	None	
Towel Rack	- S - -	None	
Tub/Shower	- S - -	None	
Walls	- - ! -	Cleaning Required

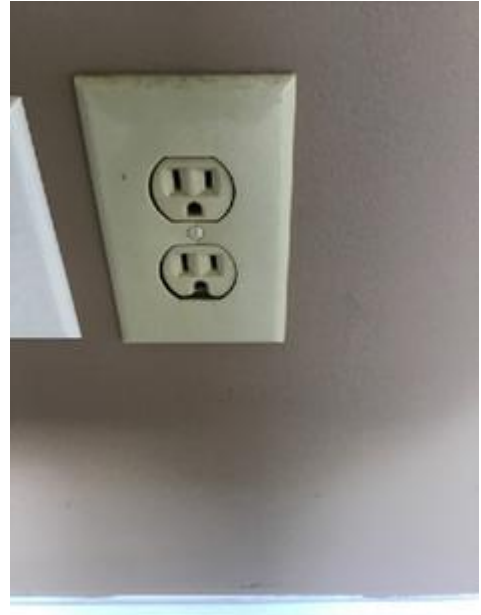
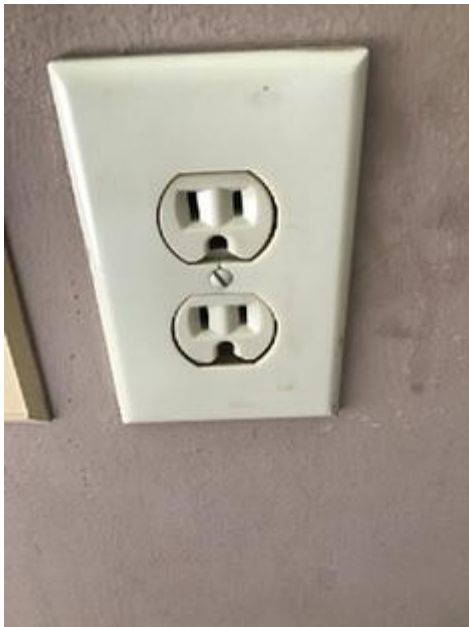
Bedroom: Master bedroom	CONDITION	ACTION	COMMENTS
Baseboard	- S - -	None	
Ceiling	- S - -	None	
Closet/Door/Track/Shelving	- S - -	None	
Door/Knob/Lock	- S - -	None	
Flooring	- S - -	None	
Light Fixture/Fan	- S - -	None	
Smoke Alarm / Battery	- S - -	None	
Switch/Outlet	- - ! -	Maintenance Required	Broken outlets
Walls	- - ! -	Painting Required	Complete repaint
Window Covering	- - ! -	Maintenance Required	Broken blinds
Window/Lock/Screen	- - ! -	Maintenance Required	Windows don't stay open

Outlets need to be replaced. It is a fire hazard to have paint on outlets. Once repairs are completed, we need to clean. There is an animal smell throughout the house

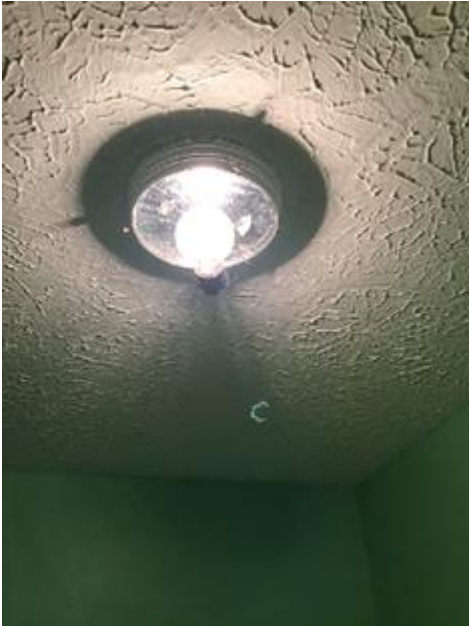
Bedroom 2	CONDITION	ACTION	COMMENTS
Baseboard	- S - -	None	
Ceiling	- S - -	None	
Closet/Door/Track/Shelving	- S - -	None	
Door/Knob/Lock	- S - -	None	
Flooring	- S - -	None	
Light Fixture/Fan	- - ! -	Maintenance Required	Missing cover- closet
Smoke Alarm / Battery	- S - -	None	
Switch/Outlet	- - ! -	Maintenance Required	Broken outlet, needs replaced
Walls	- - ! -	Painting Required	
Window Covering	- - ! -	Maintenance Required	Broken blinds
Window/Lock/Screen	- S - -	None

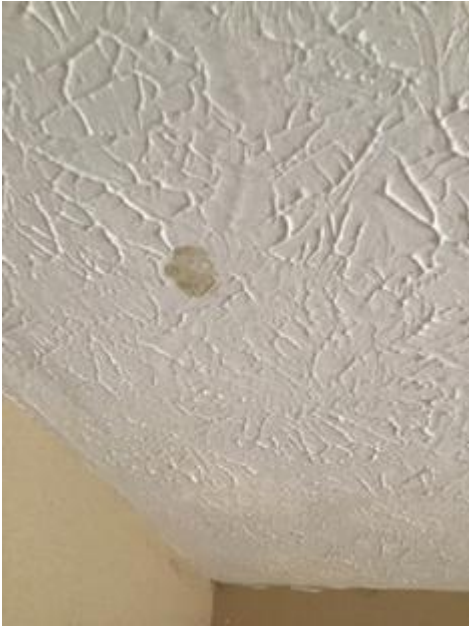
Bedroom 3	CONDITION	ACTION	COMMENTS
Baseboard	- S - -	None	
Ceiling	- - ! -	Painting Required	Water stain
Closet/Door/Track/Shelving	- S - -	None	
Door/Knob/Lock	- - ! -	Maintenance Required	Needs new divider
Flooring	- S - -	None	
Smoke Alarm / Battery	- S - -	None	
Switch/Outlet	- - ! -	Maintenance Required	Paint on and in outlets, need replaced
Walls	- - ! -	Painting Required	
Window Covering	- - ! -	Maintenance Required	Broken blinds
Window/Lock/Screen	- S - -	None

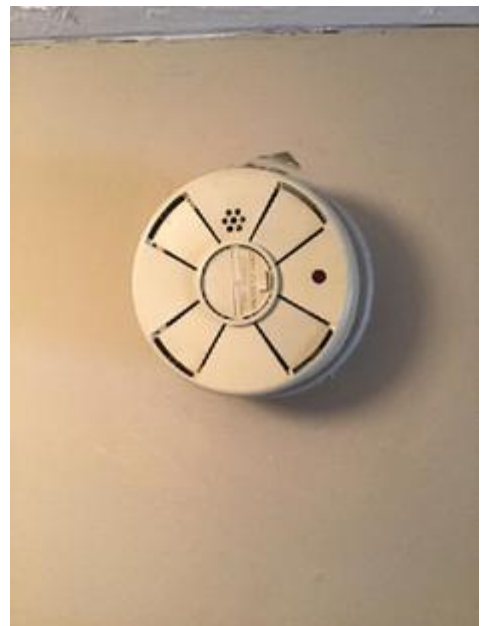
Hallway/Stairs	CONDITION	ACTION	COMMENTS
Baseboard	- S - -	None	
Ceiling	- S - -	None	
Closet/Cabinet	- S - -	None	
Flooring	- S - -	None	
Light Fixture	- S - -	None	
Smoke/CO Detector	- S - -	None	It works but it appears to be old might consider replacing. Sound was faint
Switch/Outlet	- S - -	None	
Walls	- - ! -	Painting Required

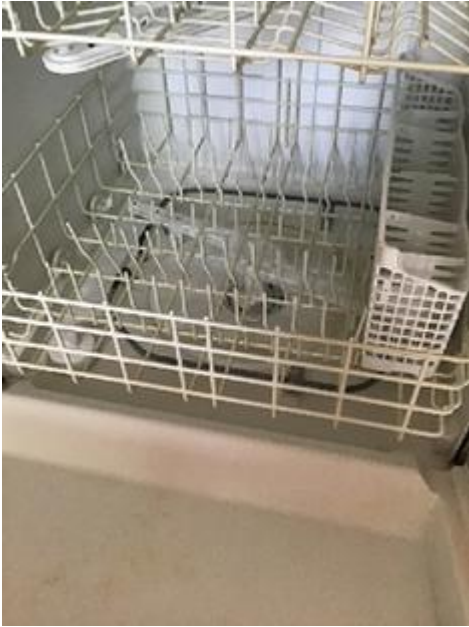
Kitchen	CONDITION	ACTION	COMMENTS
Baseboard	- S - -	None	
Cabinets/Drawers	- S - -	None	
Ceiling	- S - -	None	
Counter	- S - -	None	
Dishwasher	- - ! -	Maintenance Required	Barely any water goes to dishwasher
Faucet/Plumbing	- - ! -	Maintenance Required	Hot water trickles out, faucet is loose
Flooring	- S - -	None	
Garbage Disposal	- S - -	None	
Kitchen Sink	- S - -	None	
Light Fixture	- S - -	None	
Microwave	- - ! -	Maintenance Required	Handle is broken
Oven	- S - -	None	
Oven type: Gas or Electric?	- S - -	None	Electric
Refrigerator	- S - -	None	
Switch/Outlet	- S - -	None	
Walls	- S - -	None	
Window Covering	- - ! -	Maintenance Required	Broken blinds
Window/Lock/Screen	- - ! -	Maintenance Required	Windows don't stay open

Need to call a plumber out to the property and have them look at plumbing. Hot water isn't getting to any sink or toilet but water heater is working.

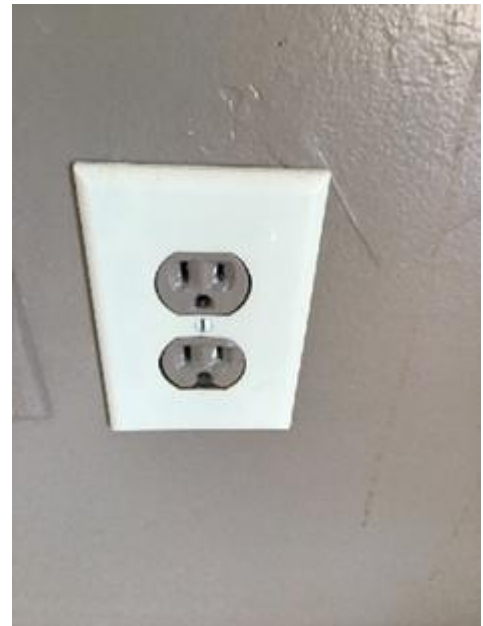
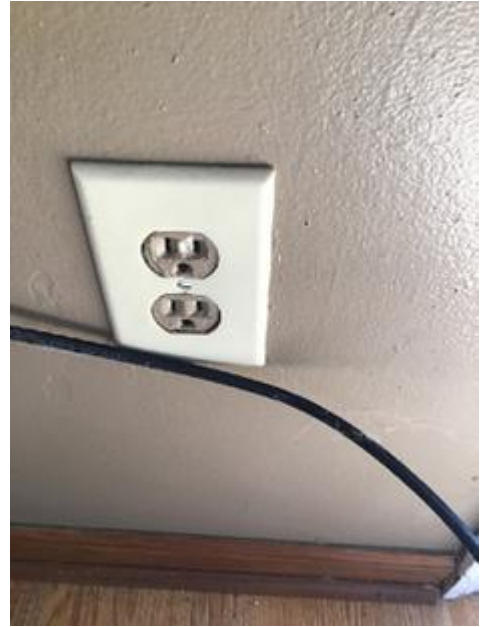
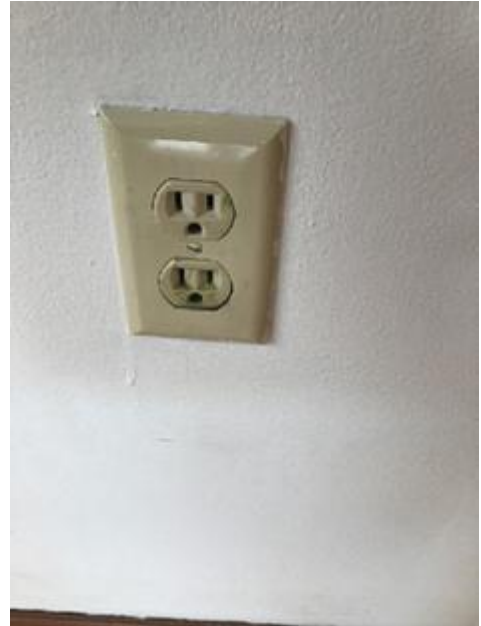
Living Room	CONDITION	ACTION	COMMENTS
Baseboard	- S - -	None	
Ceiling	- S ! -	Maintenance Required	
Door/Knob/Lock	- S - -	None	
Flooring	- S - -	None	
Light Fixture/Fan	- S - -	None	
Switch/Outlet	- - ! -	Maintenance Required	Broken or painted on, need to replace those
Walls	- - ! -	Painting Required	Needs screws taken out, patched, and repainted
Window Covering	- S - -	None	
Window/Lock/Screen	- S - -	None

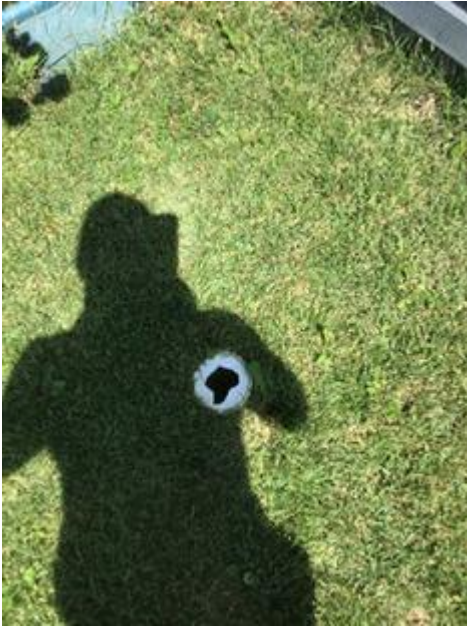
Systems	CONDITION	ACTION	COMMENTS
Breaker Box	- S - -	None	
Furnace	- S - -	None	
Furnace Filter Date	- S - -	None	9/30/2020
Furnace filter size	- S - -	None	18x20x1
Sewer Cleanout	- - ! -	Maintenance Required	Needs new cap
Thermostat	- S - -	None	
Water Heater	- S - -	None
