Move Out

Move-Out Conditions

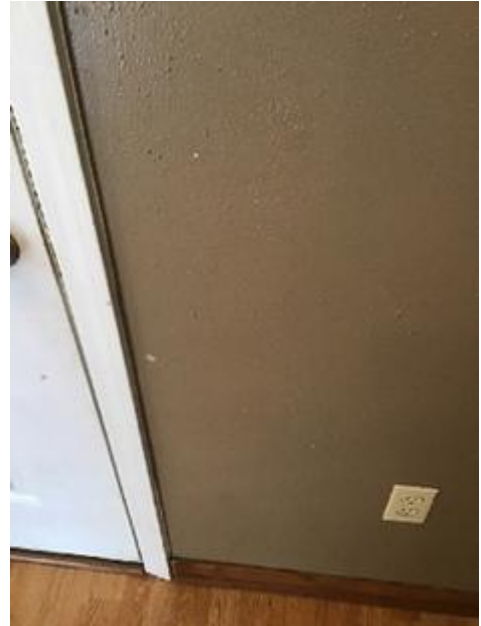
Entry	CONDITION	ACTION	COMMENTS
Baseboard	- S - -	None	
Ceiling	- S - -	None	
Door/Knob/Lock	- S - -	None	
Flooring	- S - -	None	
Light Fixture/Fan	- - ! -	Cleaning Required	Needs cleaned, cobwebs
Security/Screen Door	- S ! -	Maintenance Required	Missing handle
Switch/Outlet	- - ! -	Maintenance Required	Missing screws
Walls	- S - -	None	Some marks on wall

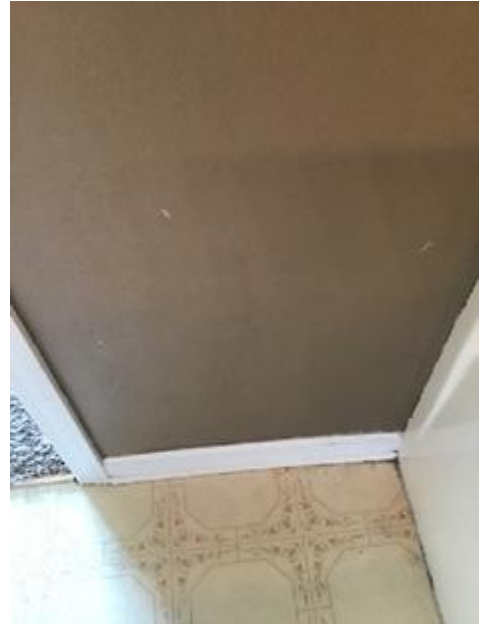
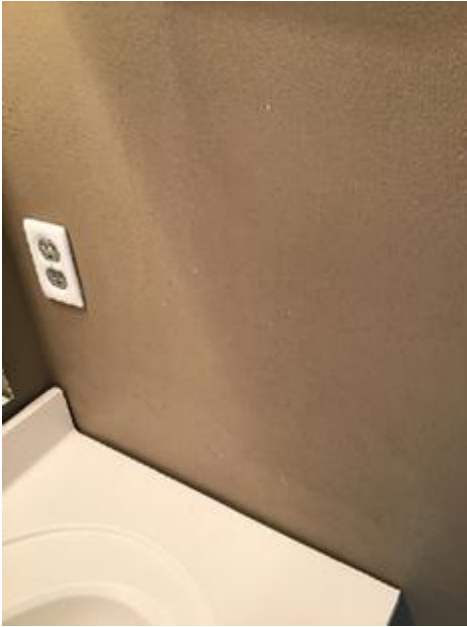
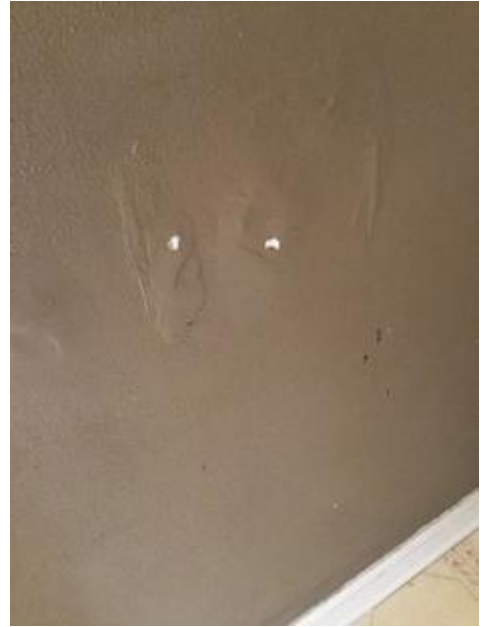
Bathroom: Master bathroom	CONDITION	ACTION	COMMENTS
Baseboard	- S - -	None	
Cabinet/Counter/Shelving	- S - -	None	
Ceiling	- S - -	None	
Door/Knob/Lock	- S - -	None	
Exhaust Fan	- S - -	None	
Flooring	- S - -	None	
Light Fixture	- - ! -	Maintenance Required	Missing light bulb=\$5
Medicine Cabinet/Mirror	- - ! -	Cleaning Required	
Plumbing/Drain	- - ! -	Maintenance Required	Hot water trickles out of shower and sinks
Shower Door/Rail/Curtain	- S - -	None	
Sink/Faucet	- S - -	None	
Switch/Outlet	- S ! -	Maintenance Required	Outlet was painted on, needs replaced
Toilet	- S - -	None	
Toilet Paper Holder	- S - -	None	
Towel Rack	- S - -	None	
Tub/Shower	- S - -	None	
Walls	- - ! -	Painting Required	Needs paint

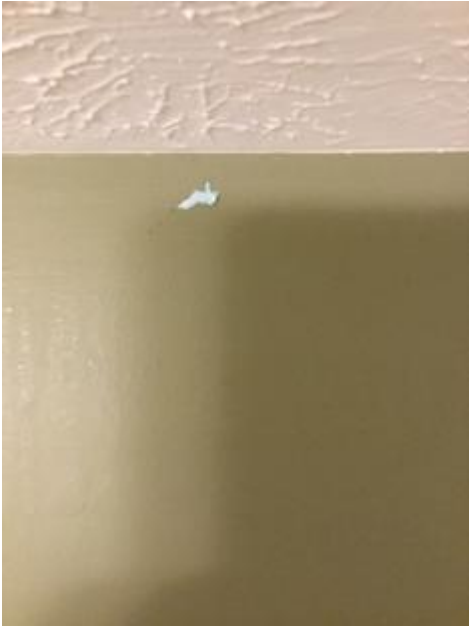
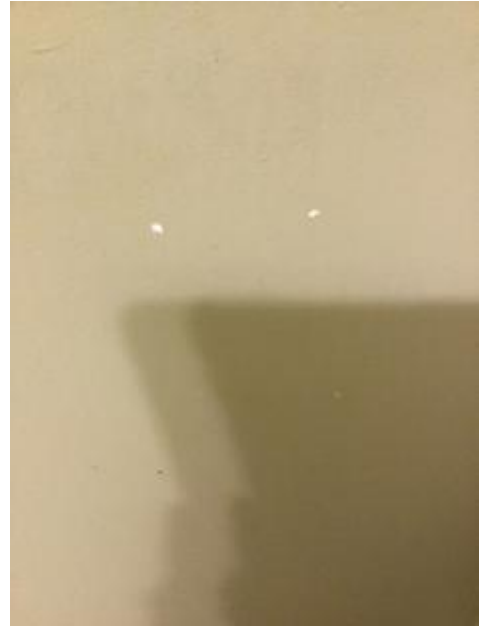
Bathroom 2	CONDITION	ACTION	COMMENTS
Baseboard	- S - -	None	
Cabinet/Counter/Shelving	- S - -	None	
Ceiling	- S - -	None	
Door/Knob/Lock	- S - -	None	
Exhaust Fan	- S - -	None	
Flooring	- - ! -	Maintenance Required	
Light Fixture	- S - -	None	Replaced light bulb-\$5
Medicine Cabinet/Mirror	- S - -	None	
Plumbing/Drain	- - ! -	Maintenance Required	Hot water trickles out of sink and shower
Shower Door/Rail/Curtain	- S - -	None	
Sink/Faucet	- S - -	None	
Switch/Outlet	- S - -	None	
Toilet	- S - -	None	
Toilet Paper Holder	- S - -	None	
Towel Rack	- S - -	None	
Tub/Shower	- S - -	None	
Walls	- - ! -	Cleaning Required

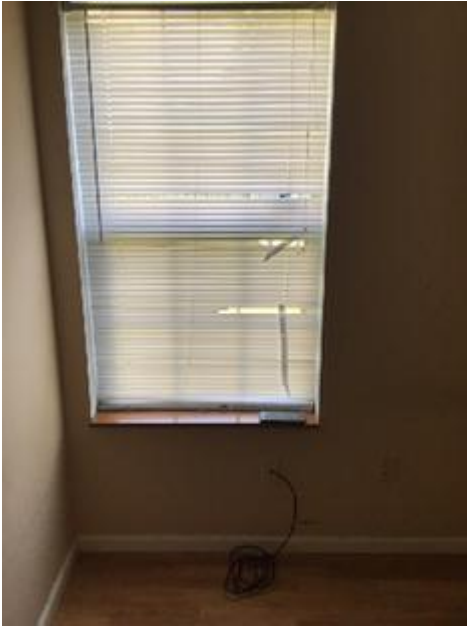
Bedroom 2	CONDITION	ACTION	COMMENTS
Baseboard	- S - -	None	
Ceiling	- S - -	None	
Closet/Door/Track/Shelving	- S - -	None	
Door/Knob/Lock	- S - -	None	
Flooring	- S - -	None	
Light Fixture/Fan	- - ! -	Maintenance Required	Missing cover- closet
Smoke Alarm / Battery	- S - -	None	
Switch/Outlet	- - ! -	Maintenance Required	Broken outlet, needs replaced
Walls	- - ! -	Painting Required	
Window Covering	- - ! -	Maintenance Required	Broken blinds
Window/Lock/Screen	- S - -	None

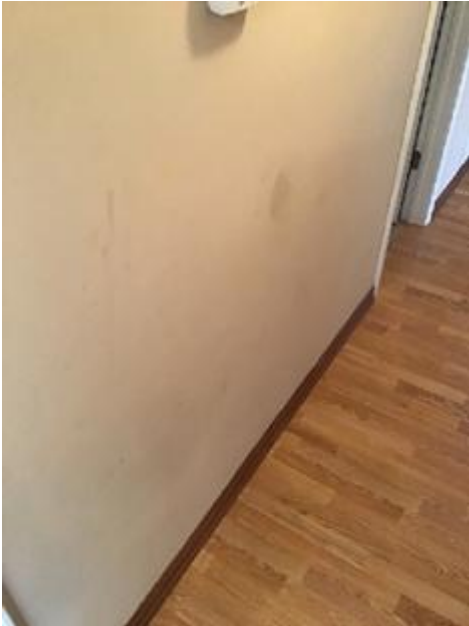
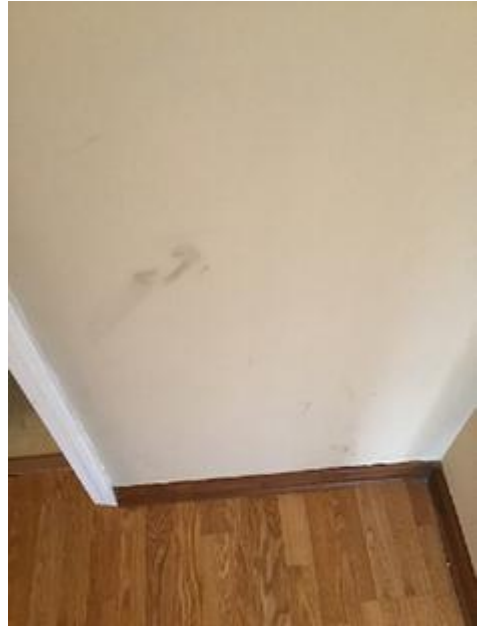
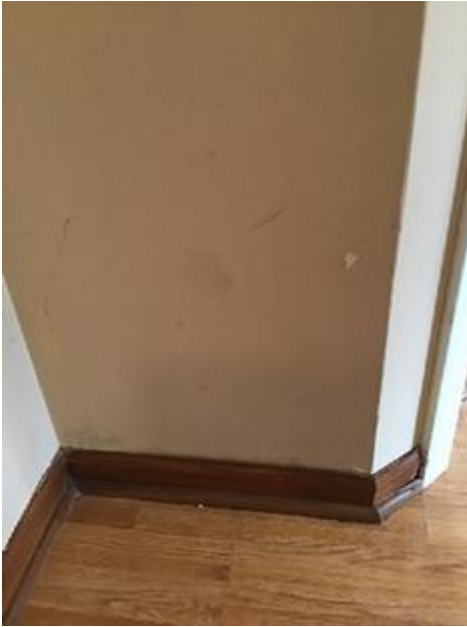
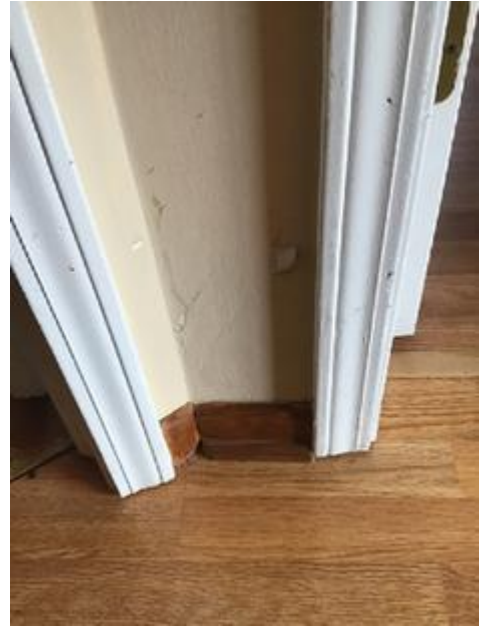
Hallway/Stairs	CONDITION	ACTION	COMMENTS
Baseboard	- S - -	None	
Ceiling	- S - -	None	
Closet/Cabinet	- S - -	None	
Flooring	- S - -	None	
Light Fixture	- S - -	None	
Smoke/CO Detector	- S - -	None	It works but it appears to be old might consider replacing. Sound was faint
Switch/Outlet	- S - -	None	
Walls	- - ! -	Painting Required

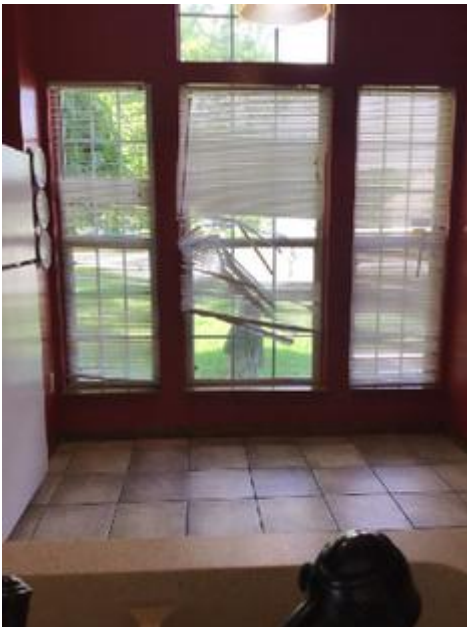
Kitchen	CONDITION	ACTION	COMMENTS
Baseboard	- S - -	None	
Cabinets/Drawers	- S - -	None	
Ceiling	- S - -	None	
Counter	- S - -	None	
Dishwasher	- - ! -	Maintenance Required	Barely any water goes to dishwasher
Faucet/Plumbing	- - ! -	Maintenance Required	Hot water trickles out, faucet is loose
Flooring	- S - -	None	
Garbage Disposal	- S - -	None	
Kitchen Sink	- S - -	None	
Light Fixture	- S - -	None	
Microwave	- - ! -	Maintenance Required	Handle is broken
Oven	- S - -	None	
Oven type: Gas or Electric?	- S - -	None	Electric
Refrigerator	- S - -	None	
Switch/Outlet	- S - -	None	
Walls	- S - -	None	
Window Covering	- - ! -	Maintenance Required	Broken blinds
Window/Lock/Screen	- - ! -	Maintenance Required	Windows don't stay open

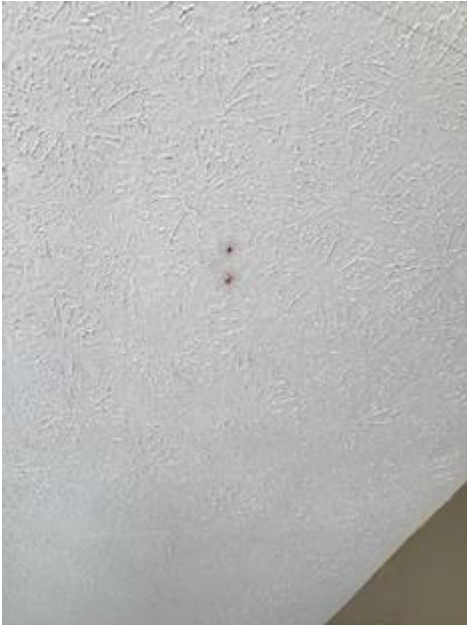
Living Room	CONDITION	ACTION	COMMENTS
Baseboard	- S - -	None	
Ceiling	- S ! -	Maintenance Required	
Door/Knob/Lock	- S - -	None	
Flooring	- S - -	None	
Light Fixture/Fan	- S - -	None	
Switch/Outlet	- - ! -	Maintenance Required	Broken or painted on, need to replace those
Walls	- - ! -	Painting Required	Needs screws taken out, patched, and repainted
Window Covering	- S - -	None	
Window/Lock/Screen	- S - -	None

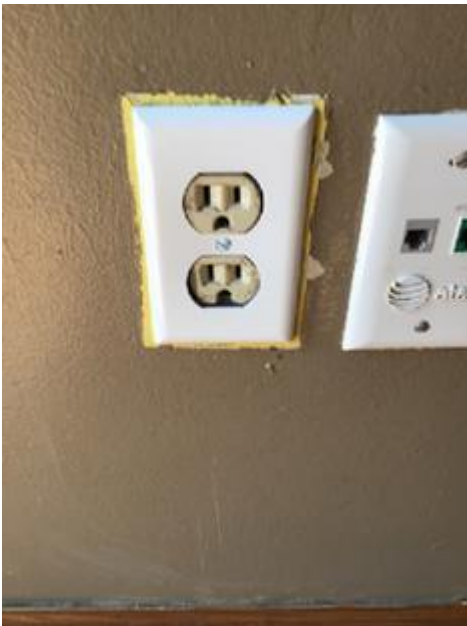
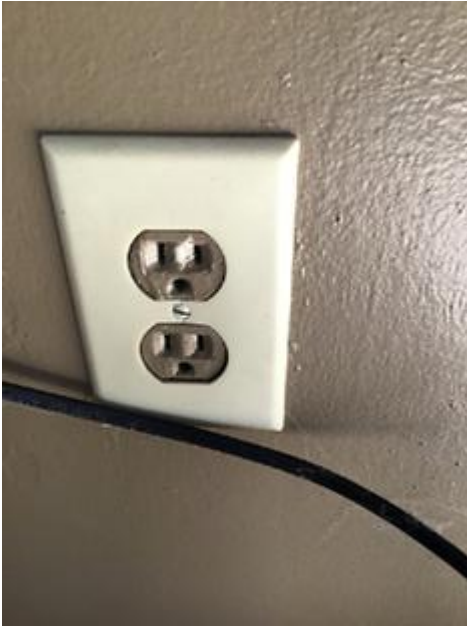
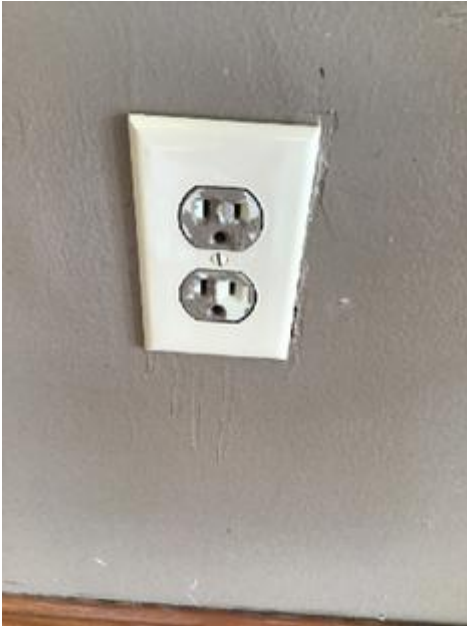
Switch/Outlet

Outlets need to be replaced. It is a fire hazard to have paint on outlets. Once repairs are completed, we need to clean. There is an animal smell throughout the house

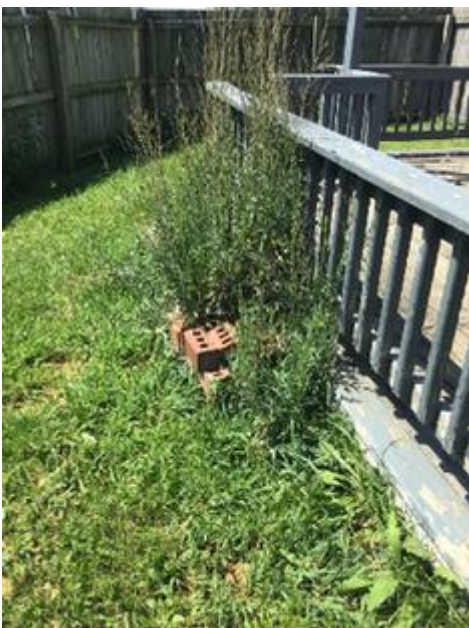
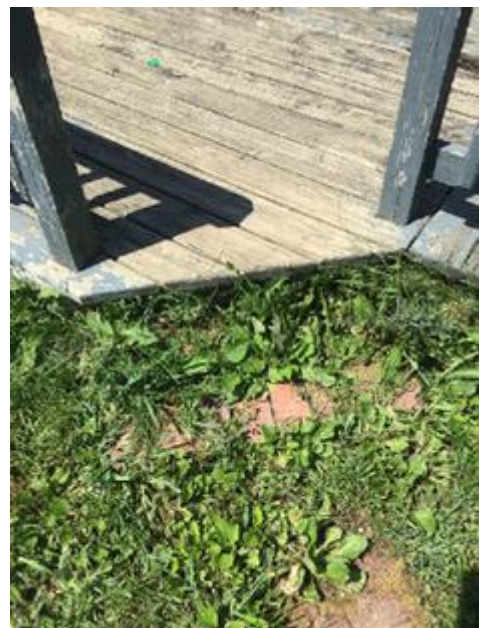
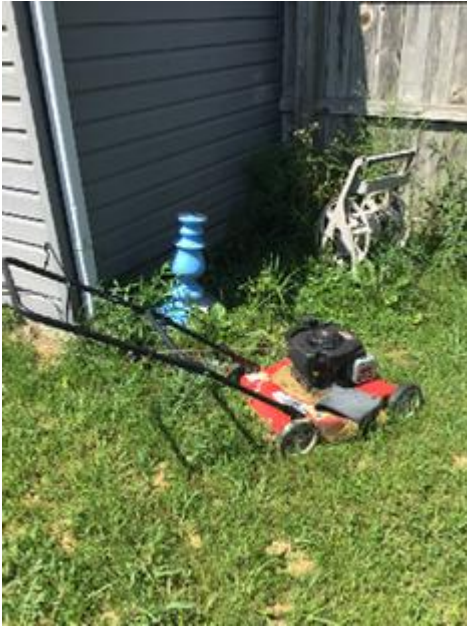
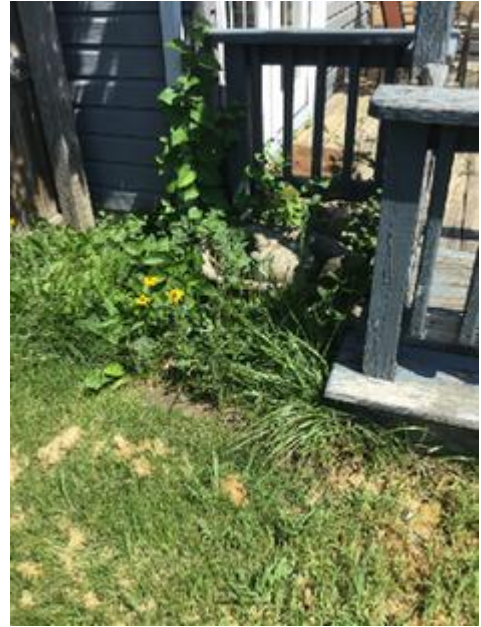
Back Yard/Exterior	CONDITION	ACTION	COMMENTS
Building Exterior	- S - -	None	
Downspouts / Gutters	- S - -	None	
Fence/Gate	- S - -	None	
Landscaping	- S ! -	Maintenance Required	
Light Fixture	- S - -	None	
Patio/Deck/Balcony	- S - -	None	Outlet needs cover
Porch/Stairs	- S - -	None	
Roof	- S - -	None	
Siding/Trim	- S - -	None
